BUREAU OF SHIPS GROUP
TECHNICAL INSPECTION REPORT

⑥ OPERATION CROSSROADS.
U.S.S HUGHES (DD410).
TEST BAKER.

VOLUME II [u] ⑧

USS HUGHES (DD410)

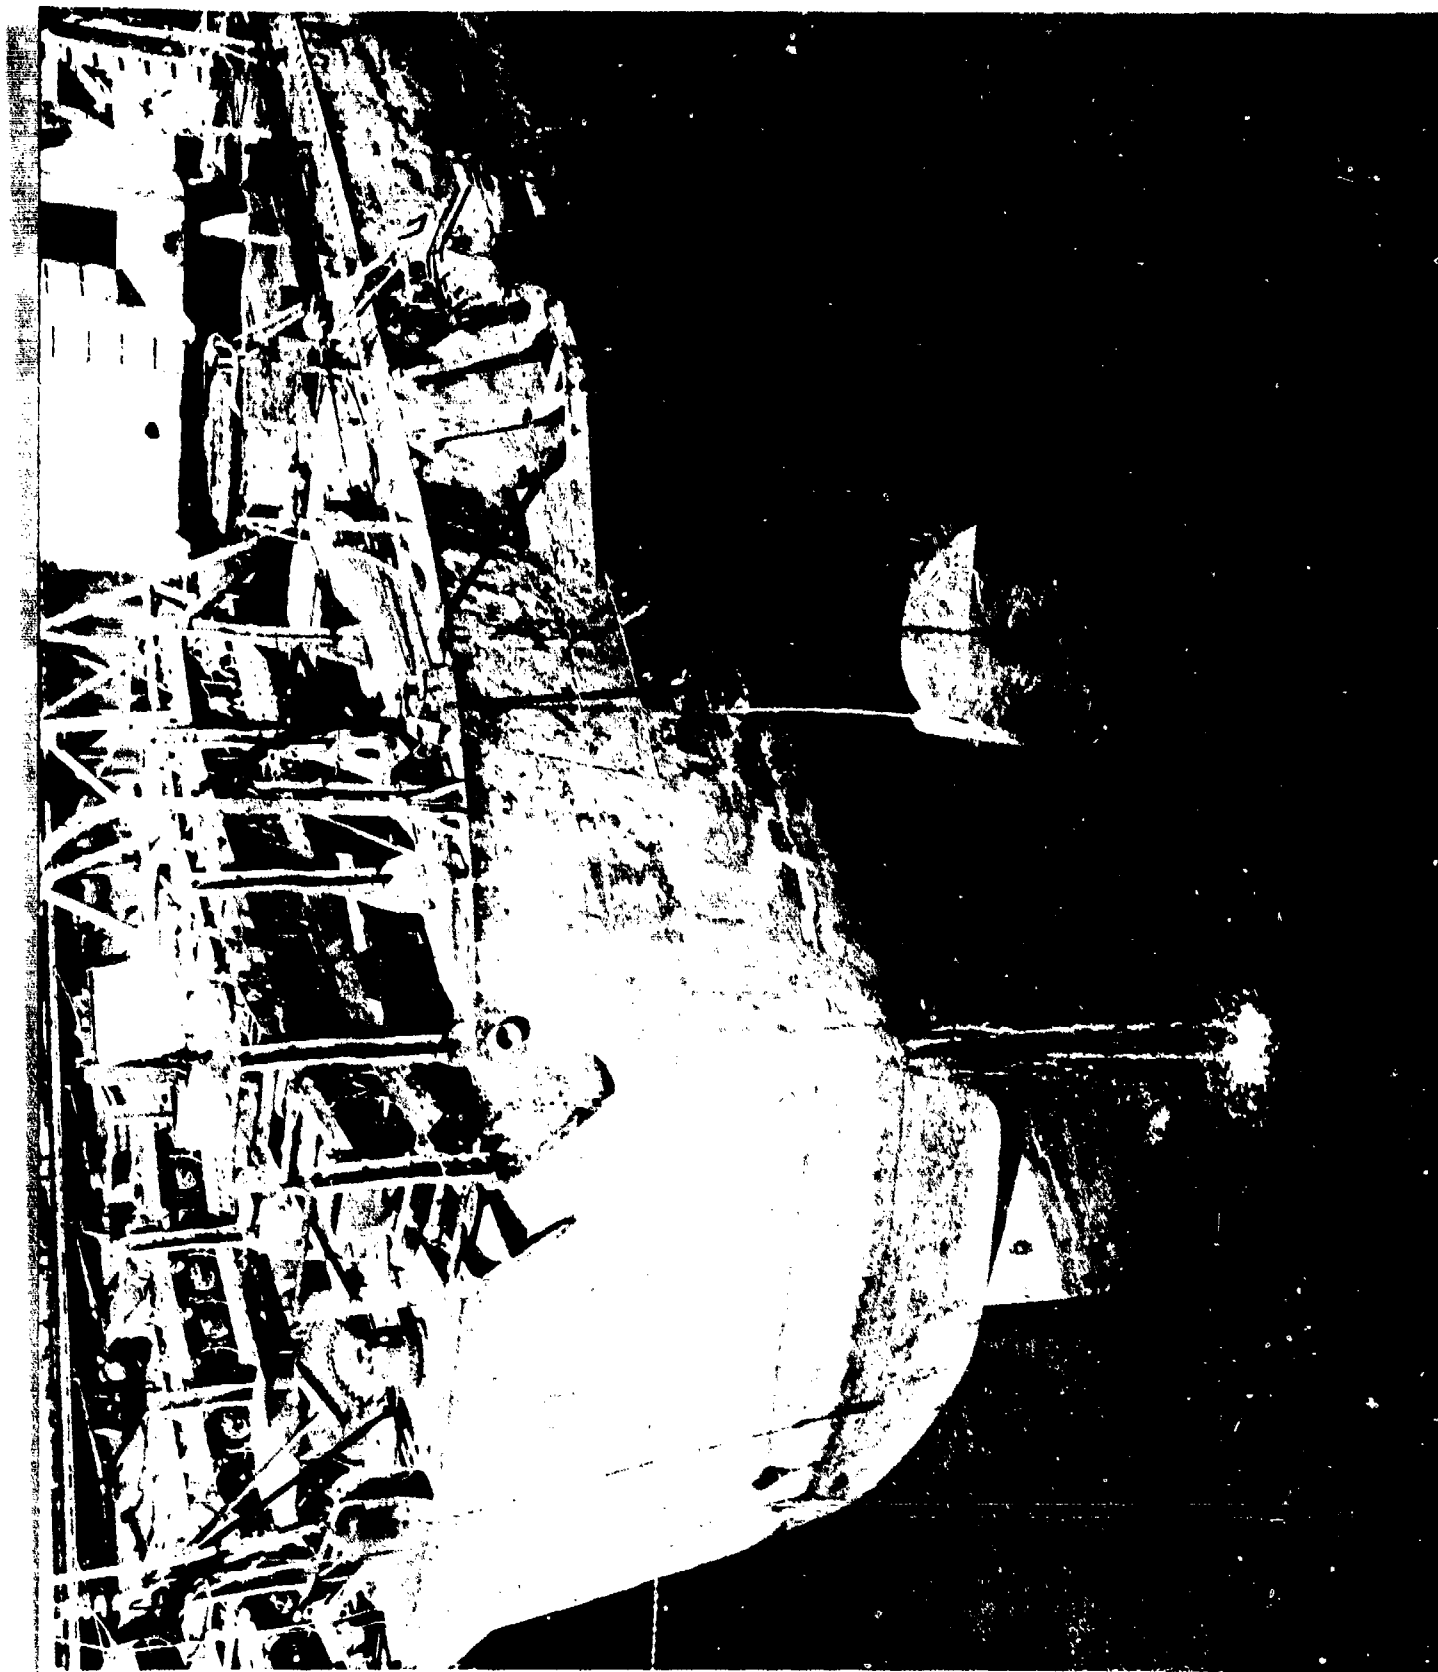
AB-CR-82-4223-11. Close-up showing depth charge racks and leakage in way of shell plating seam at starboard corner of transom.

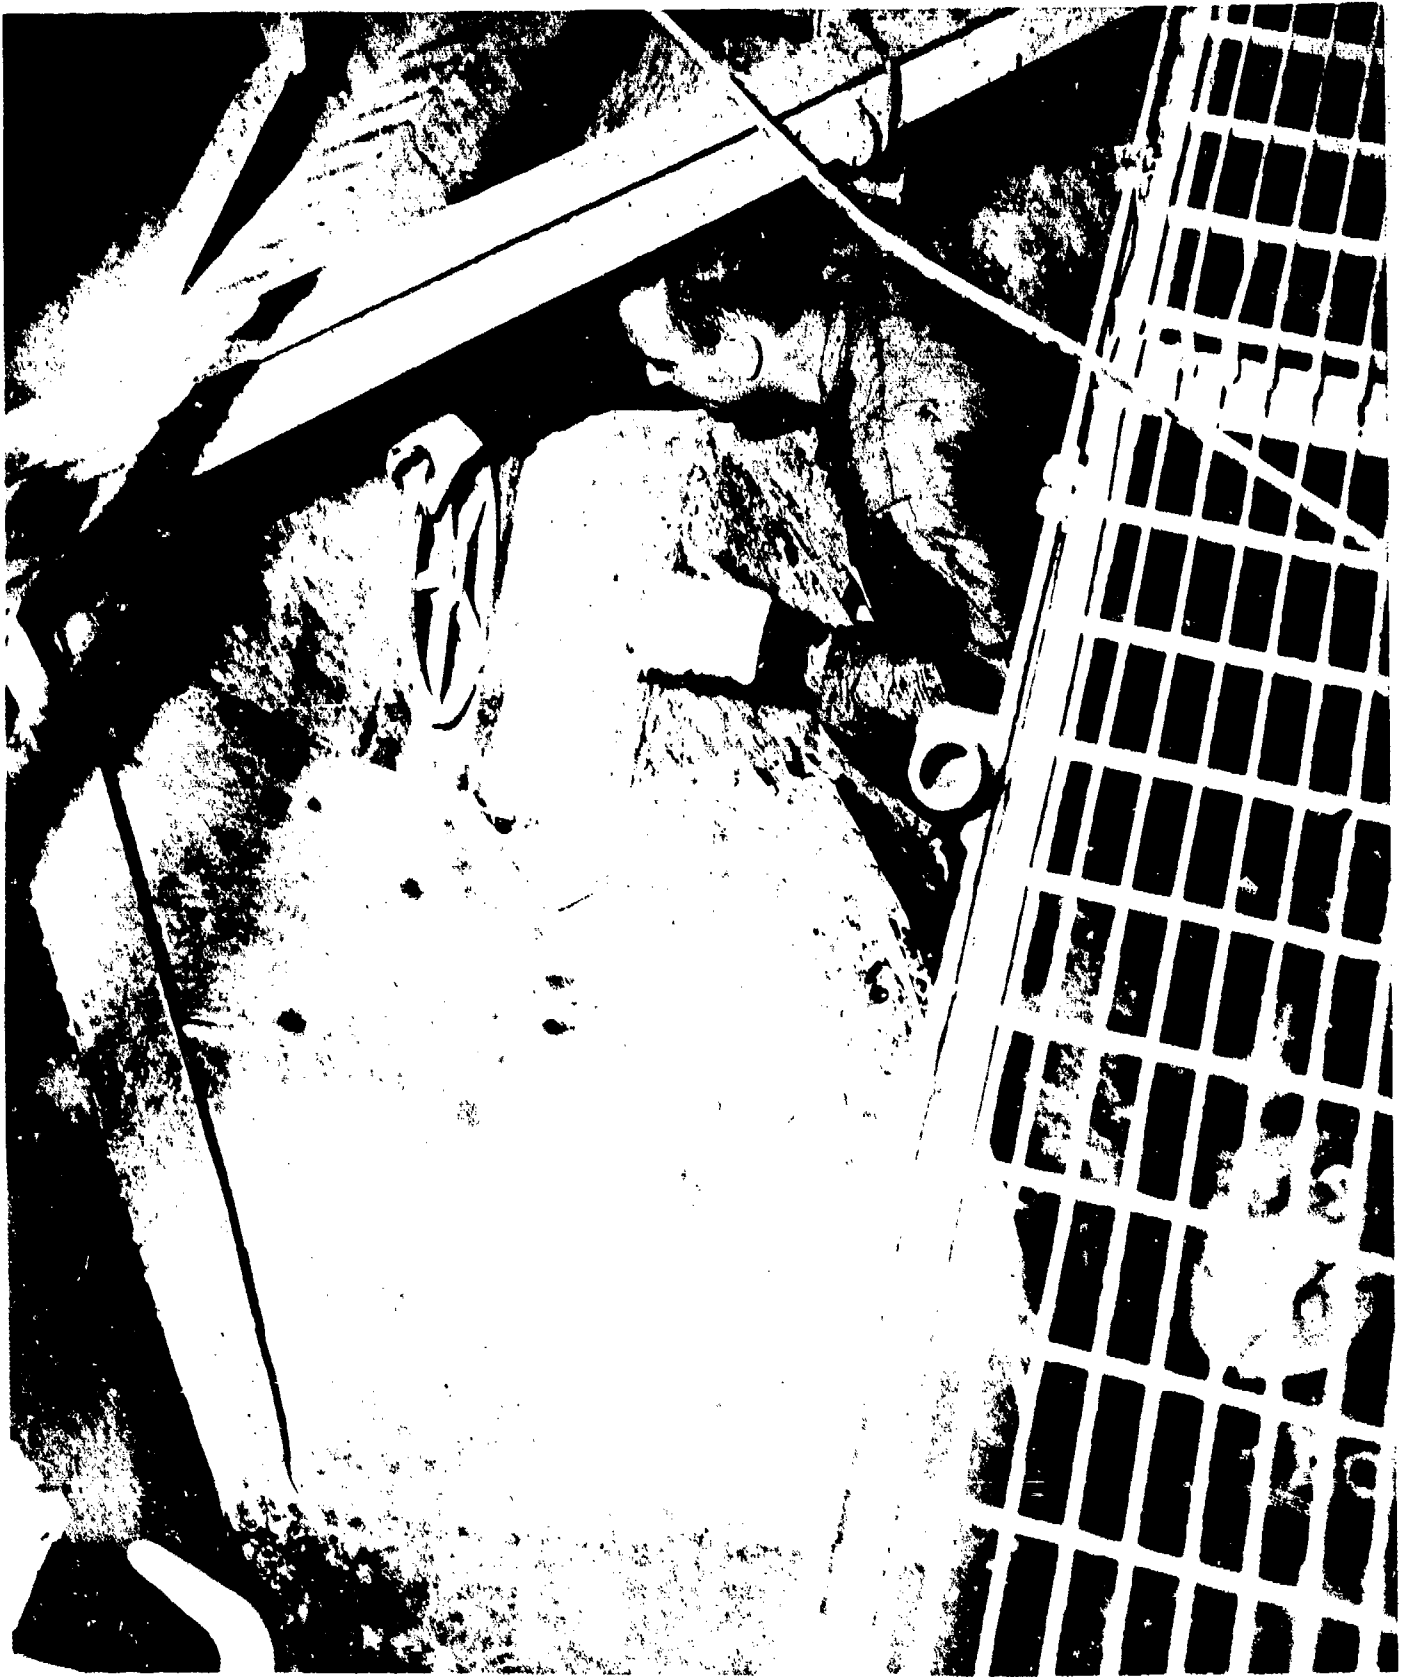
AB-CR-76-2077-7. No. 3 uptake, rupture of sheet and main frame.

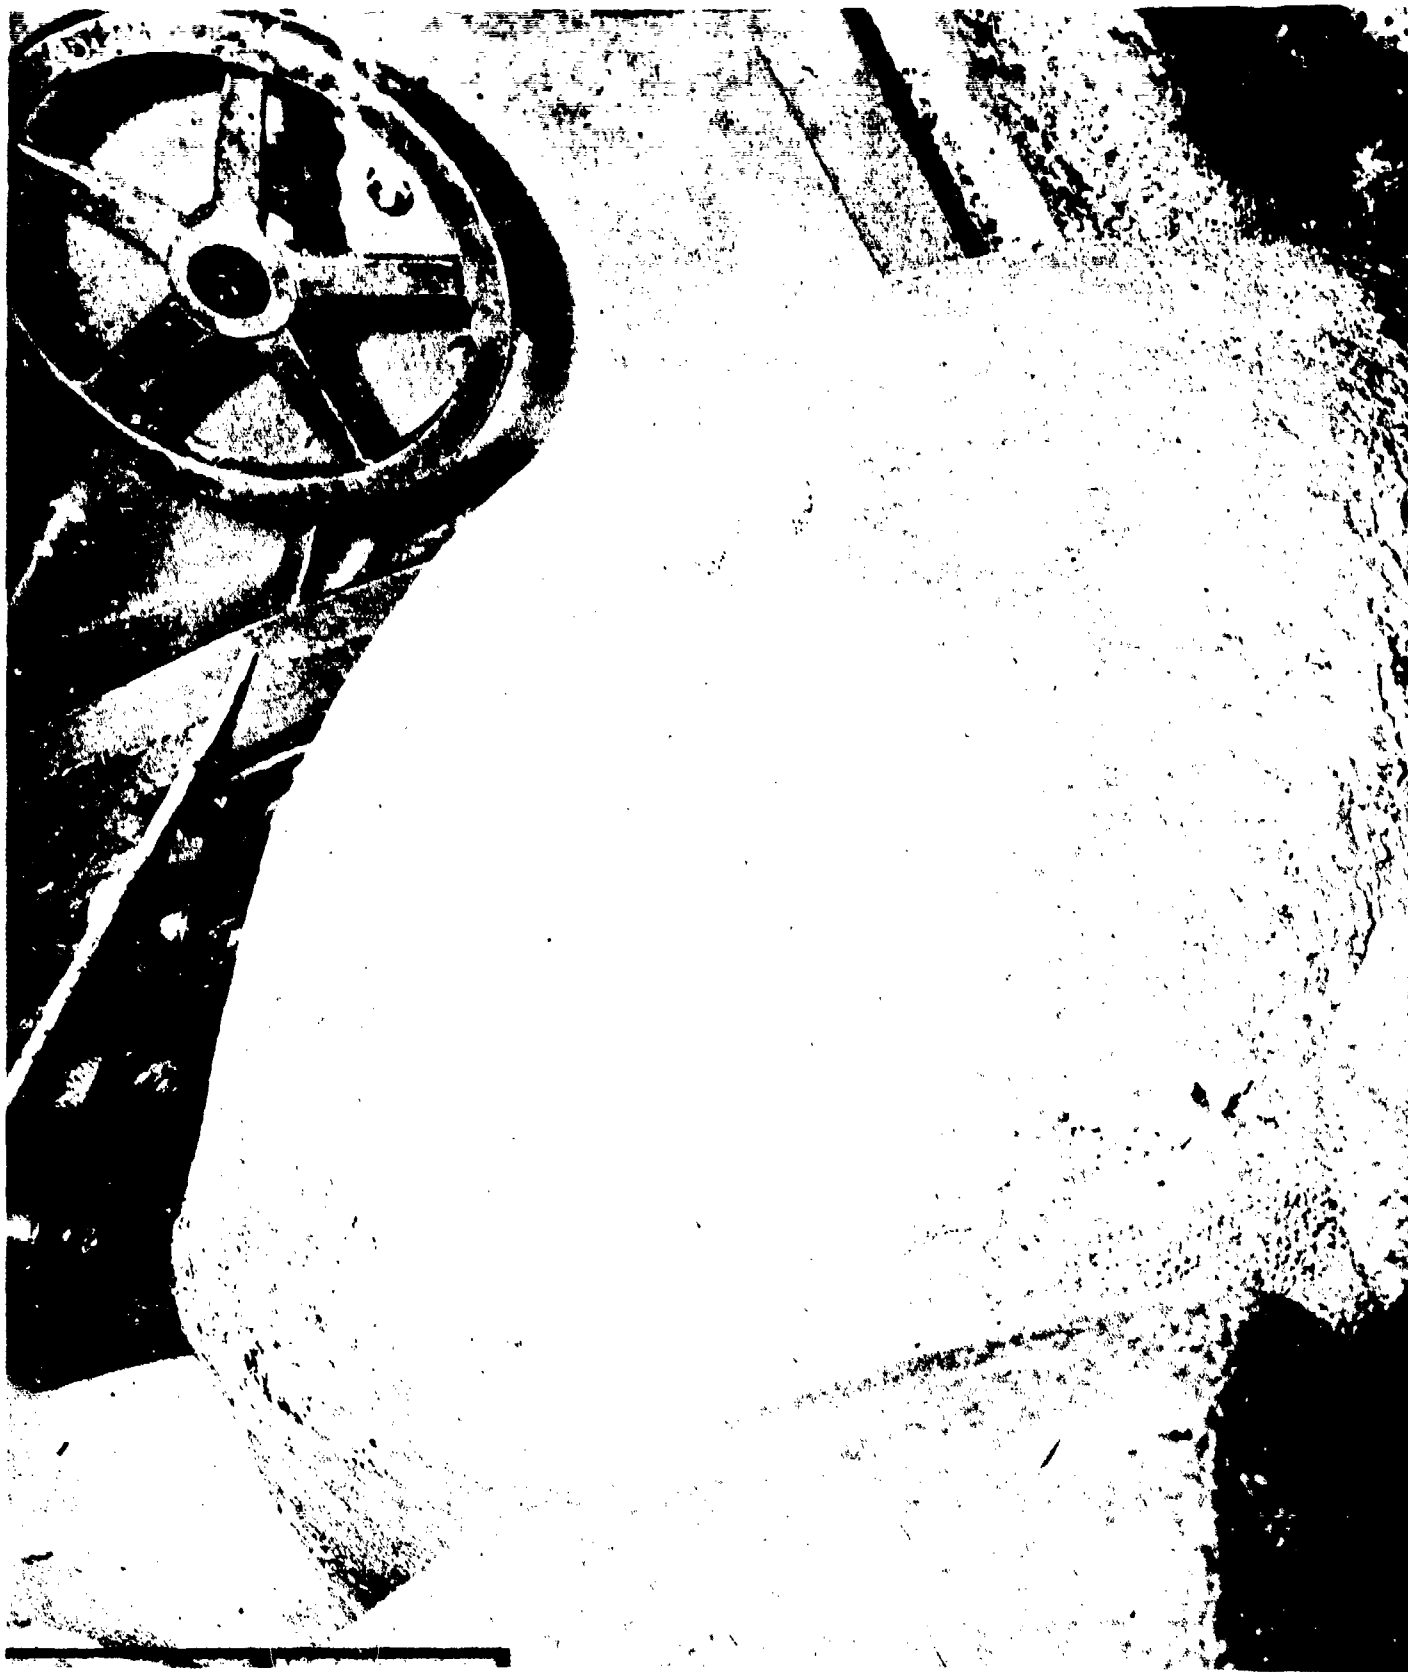
AB-CR-97-4059-9. No. 2 engine room, main steam manifold support bracket failure.

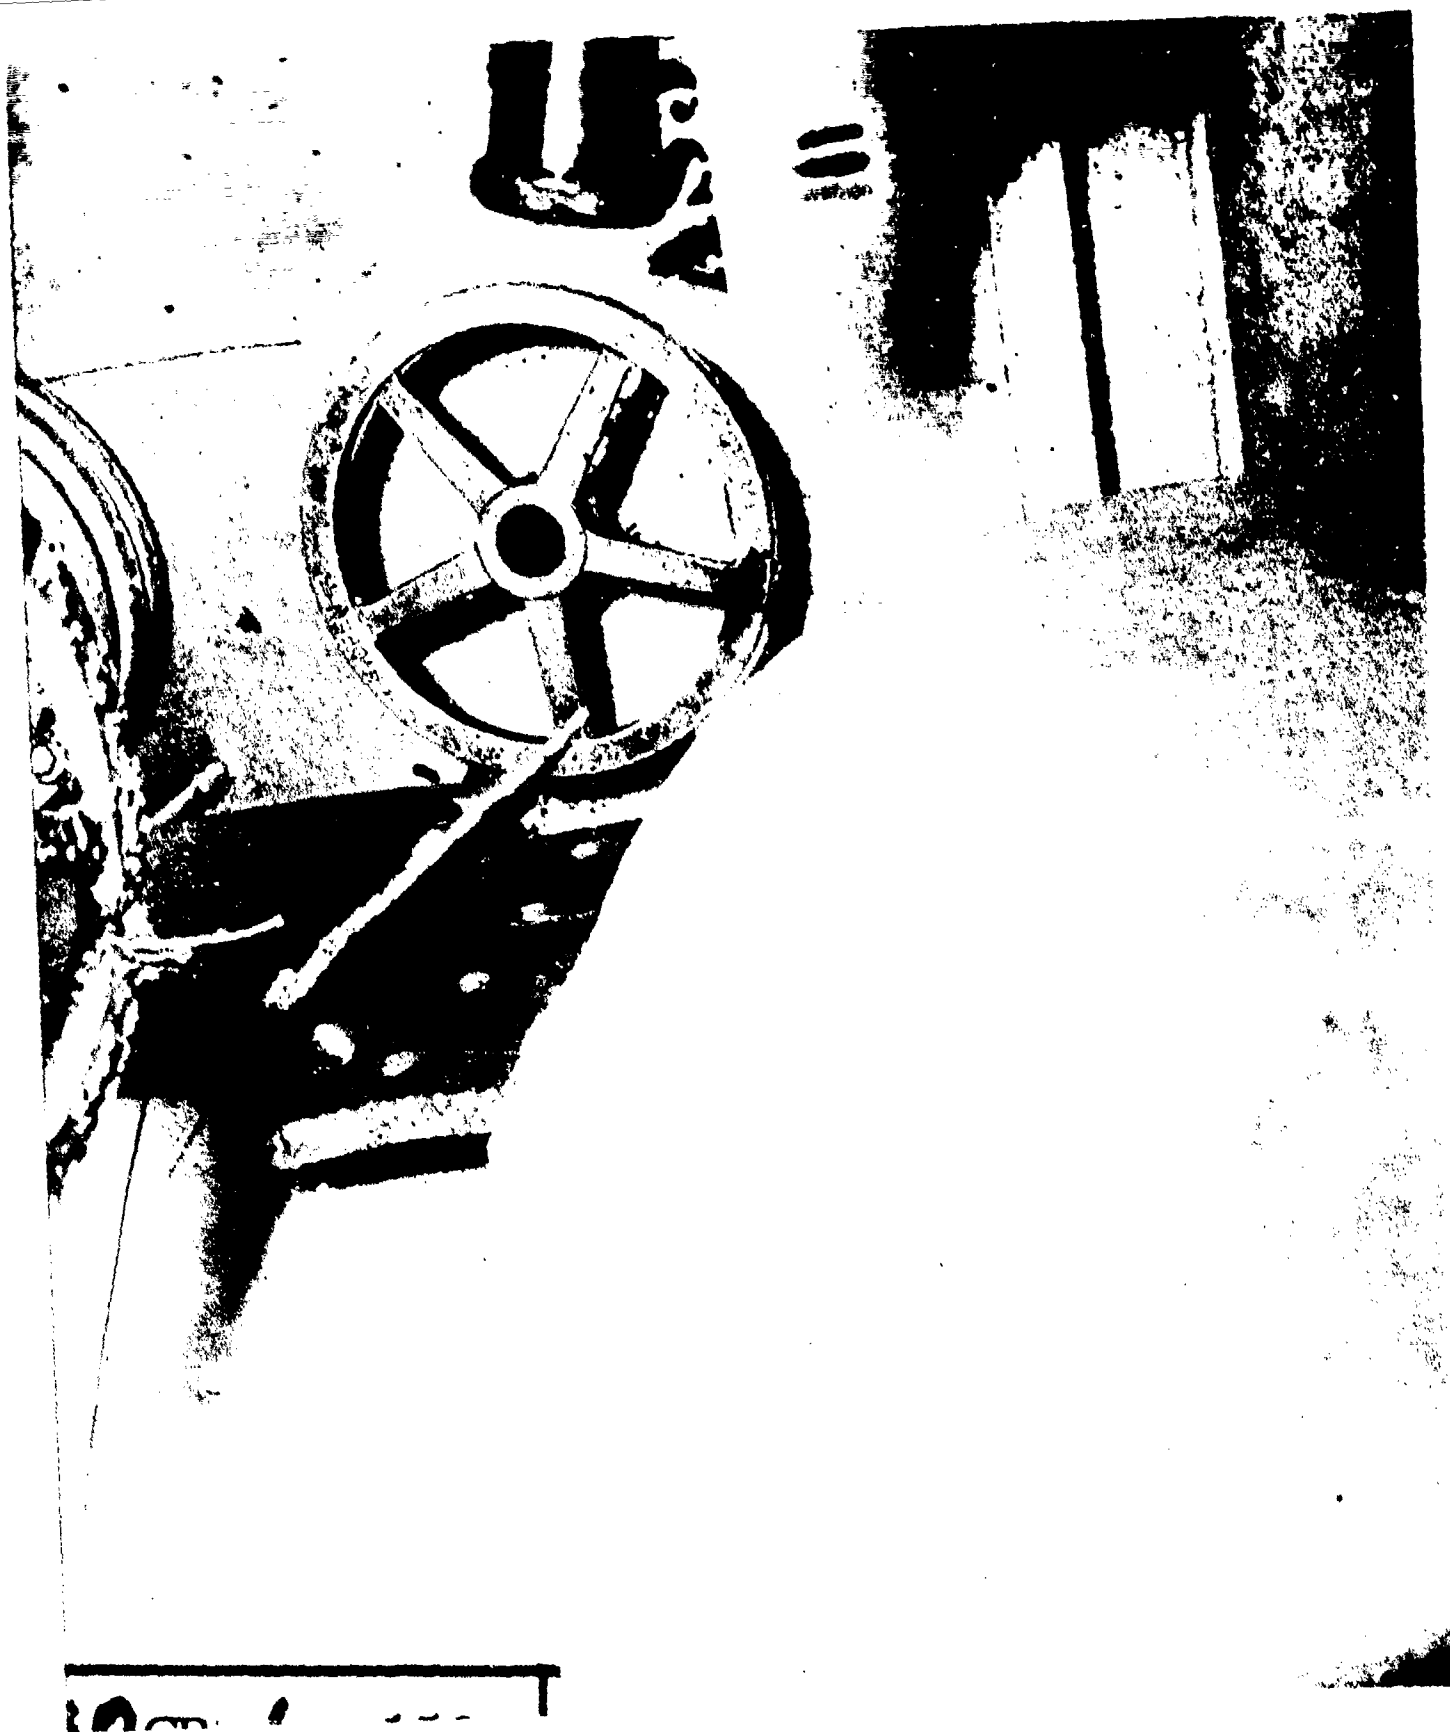
AB-CR-66-153-3. Showing No. 2 throttle valve outboard hanger failure.

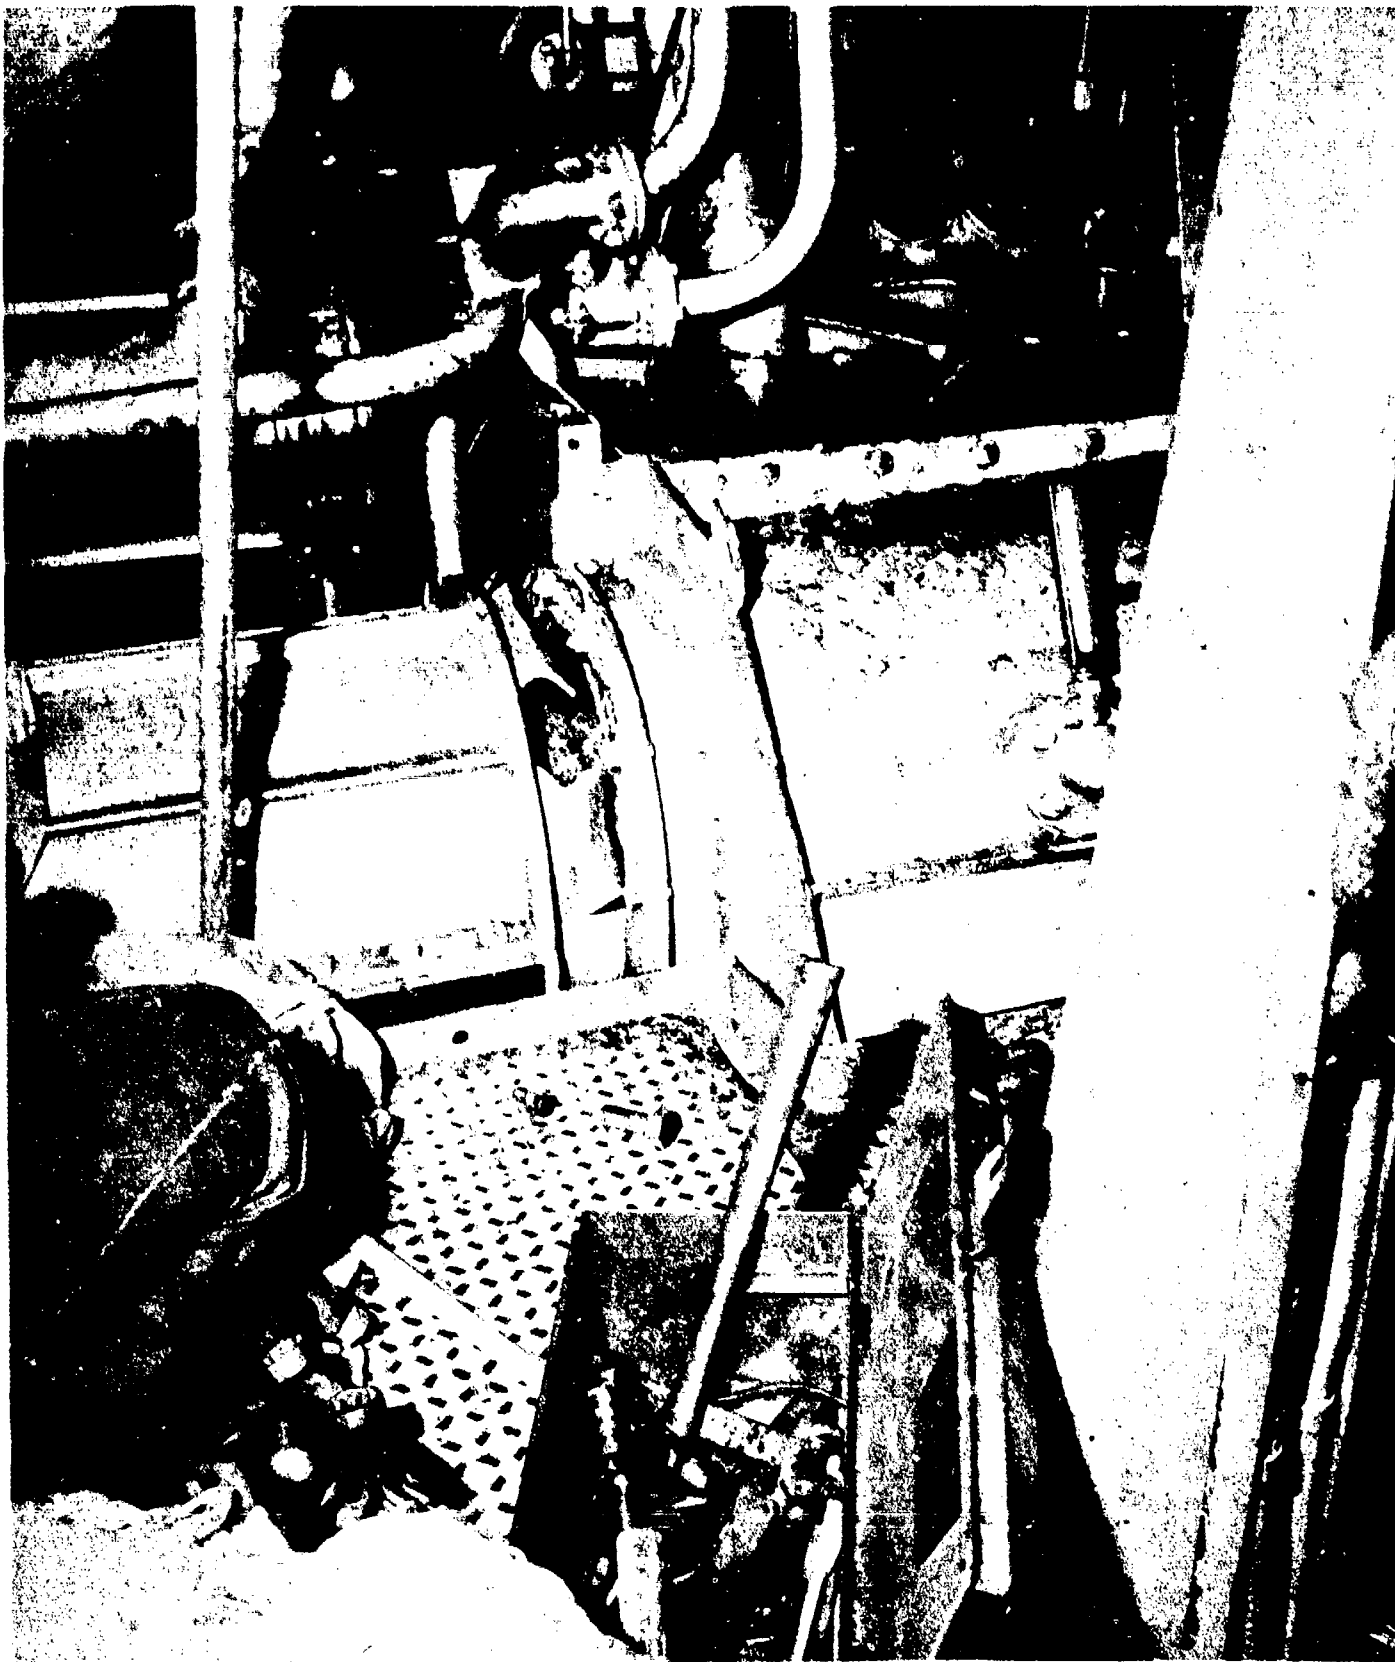
AB-CR-68-2950-10. Showing broken low pressure coupling cover at reduction gear end No. 1 engine room.

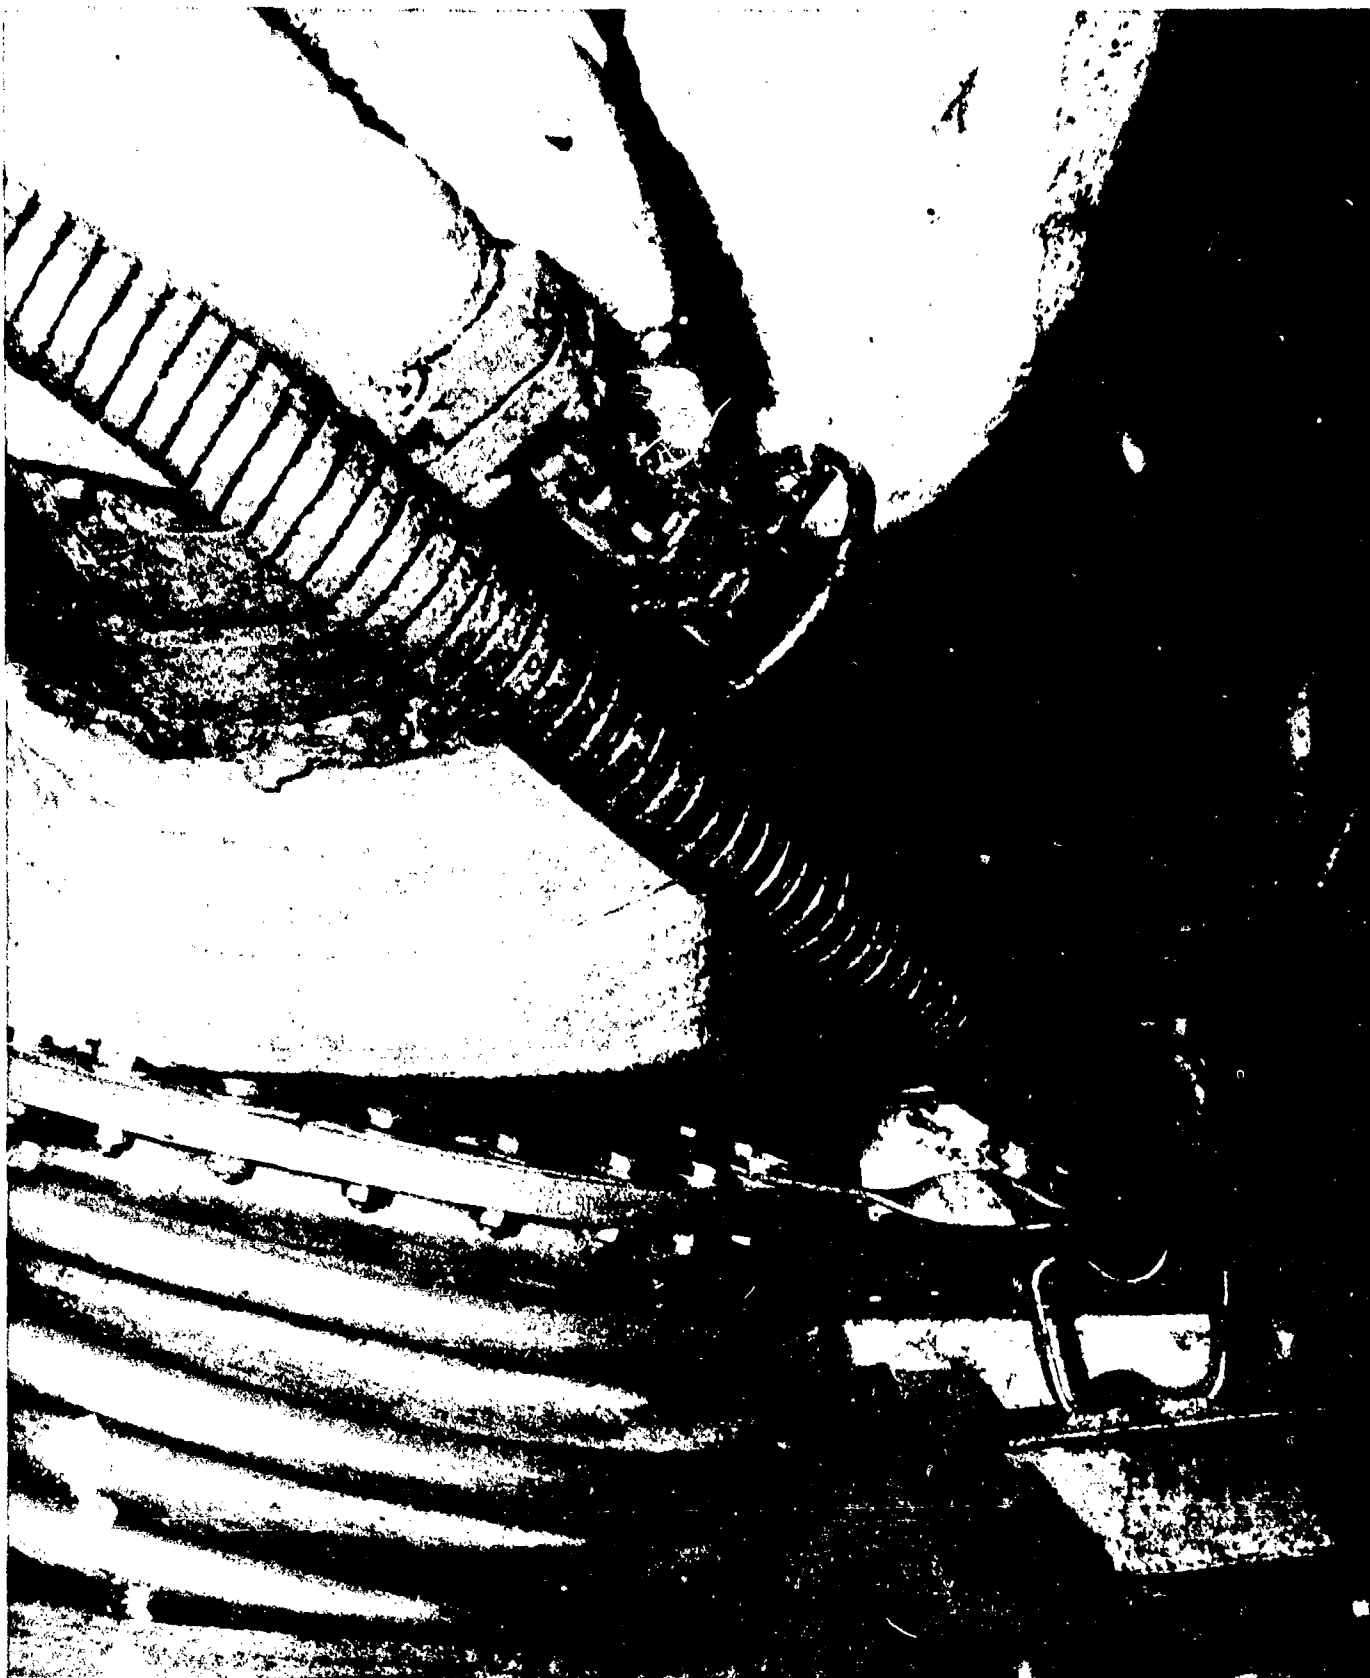
AB-CR-97-4059-10. No. 2 fire room, port side, main steam line, showing drop on line and expansion piece at bulkhead 105. Damage due to hanger failure.

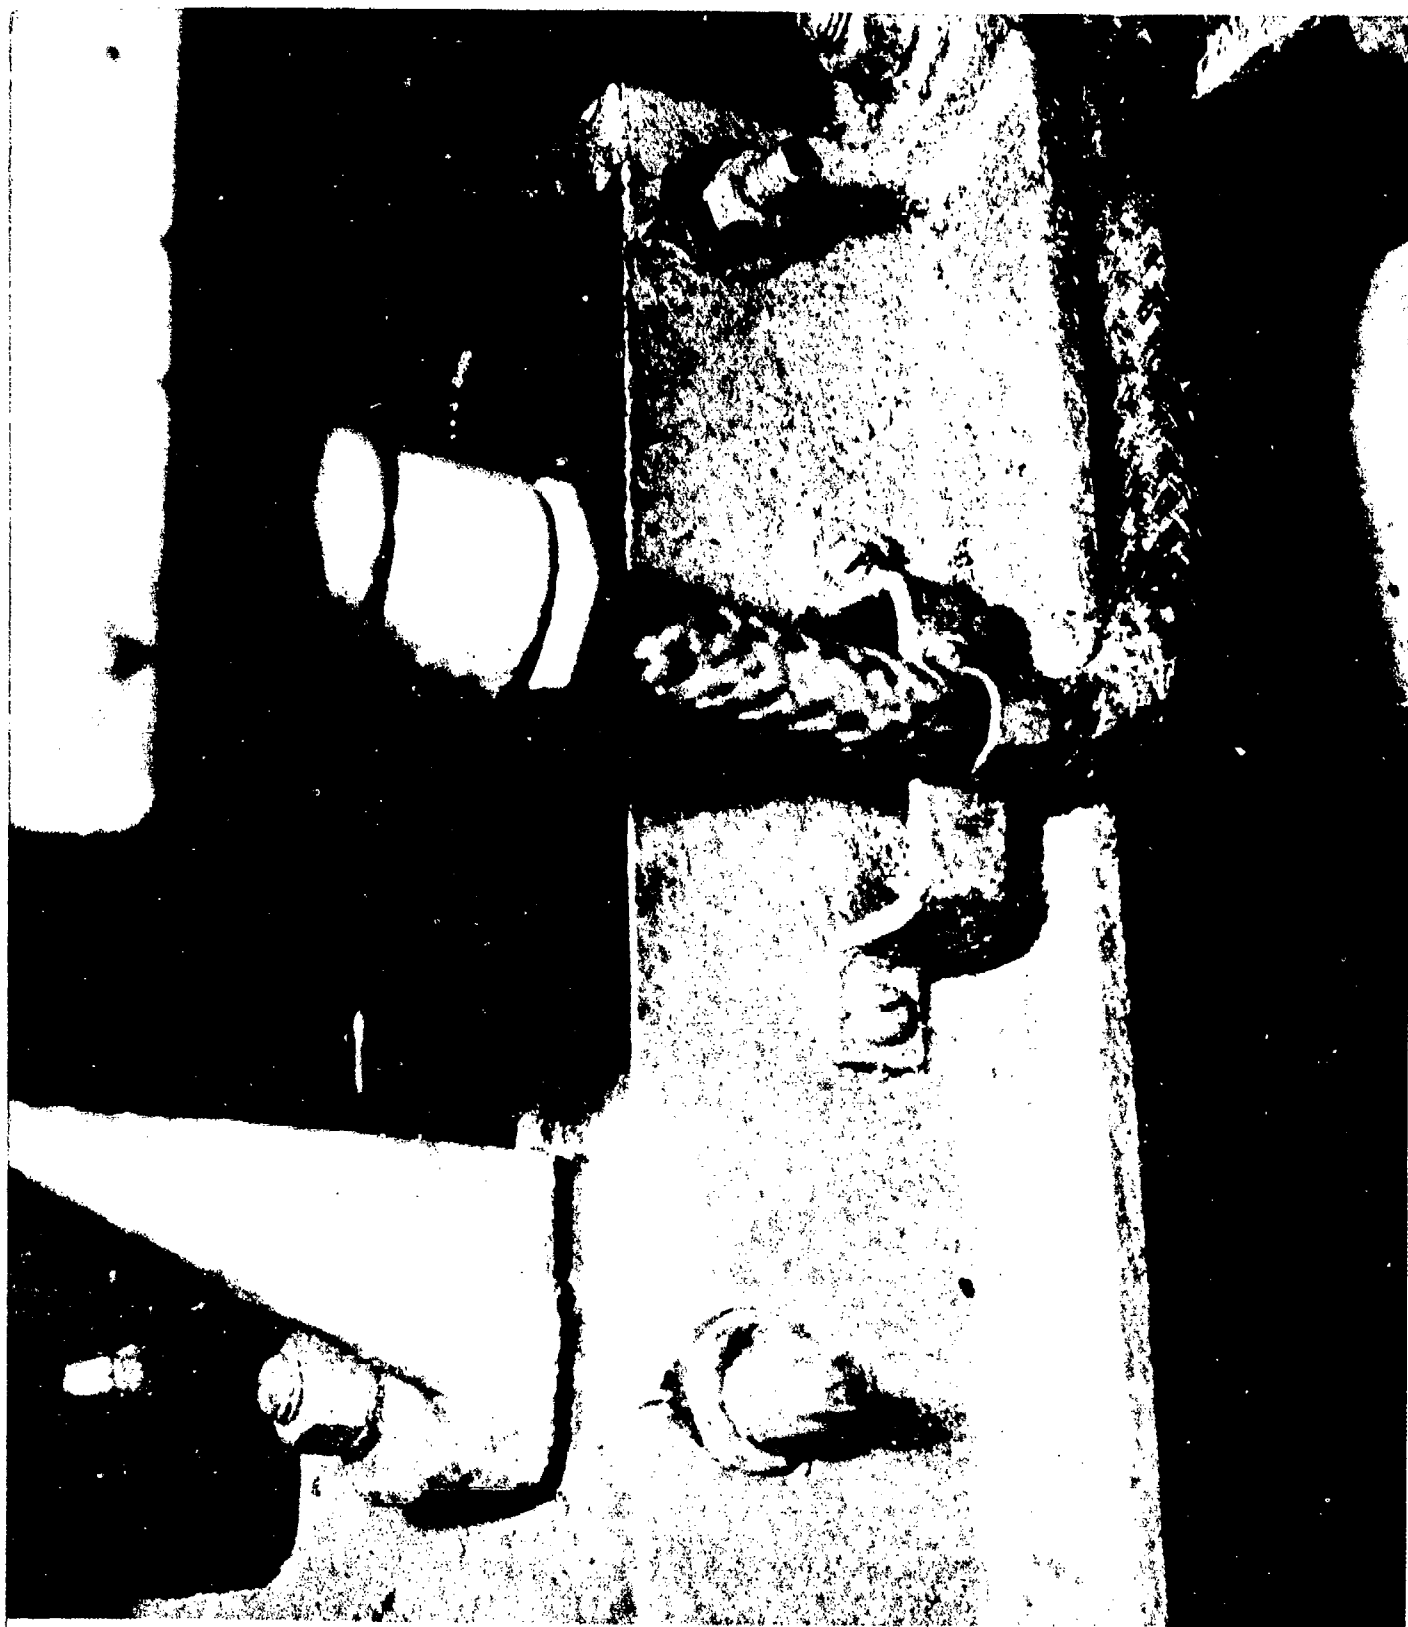
AB-CR-80-1681-4. Motor for low pressure air compressor in after fire room. Shows crack in bedplate, and mounting bolts partially stripped out of bedplate. Picture taken looking aft.

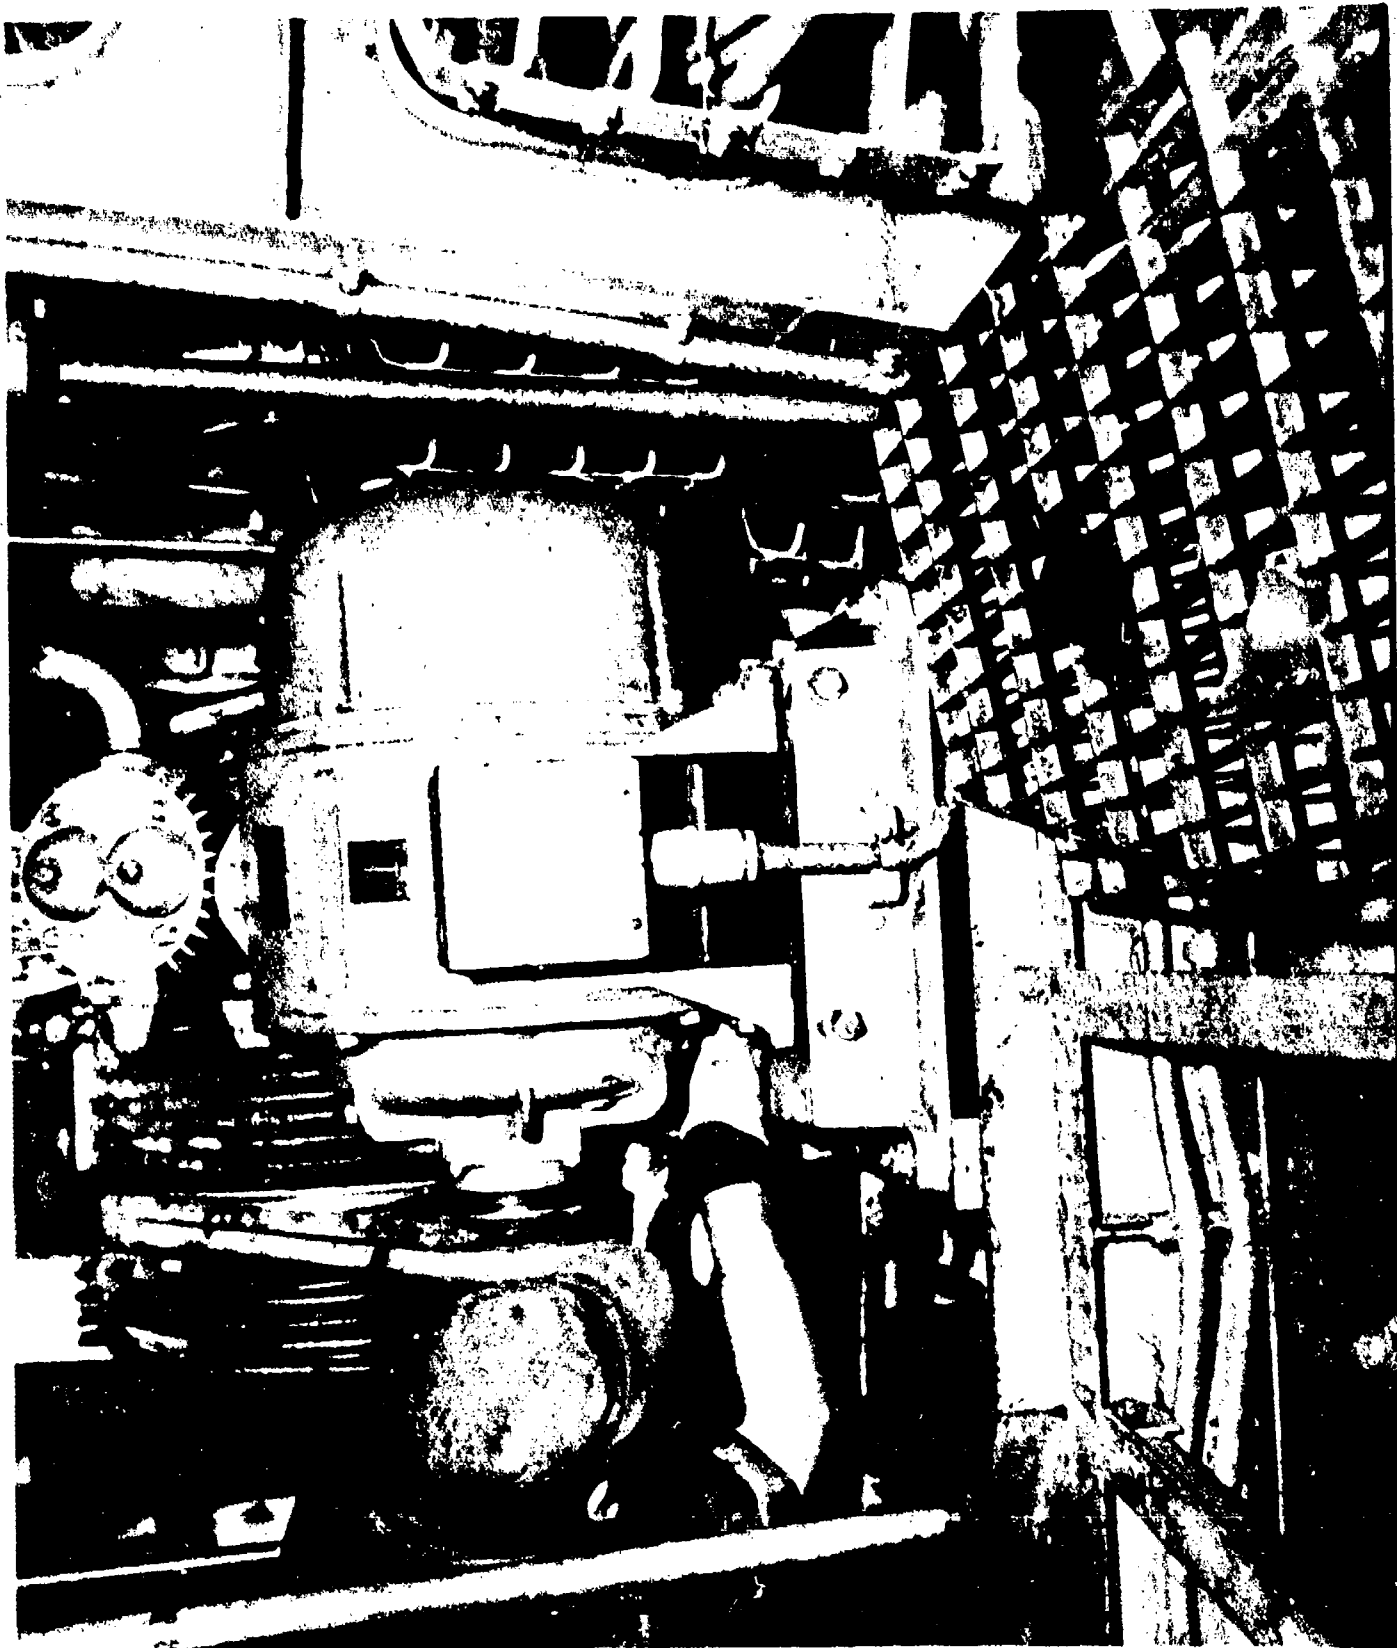
AB-CR-80-1681-5. Low pressure air compressor in after fire room.
Shows damaged motor being inspected.

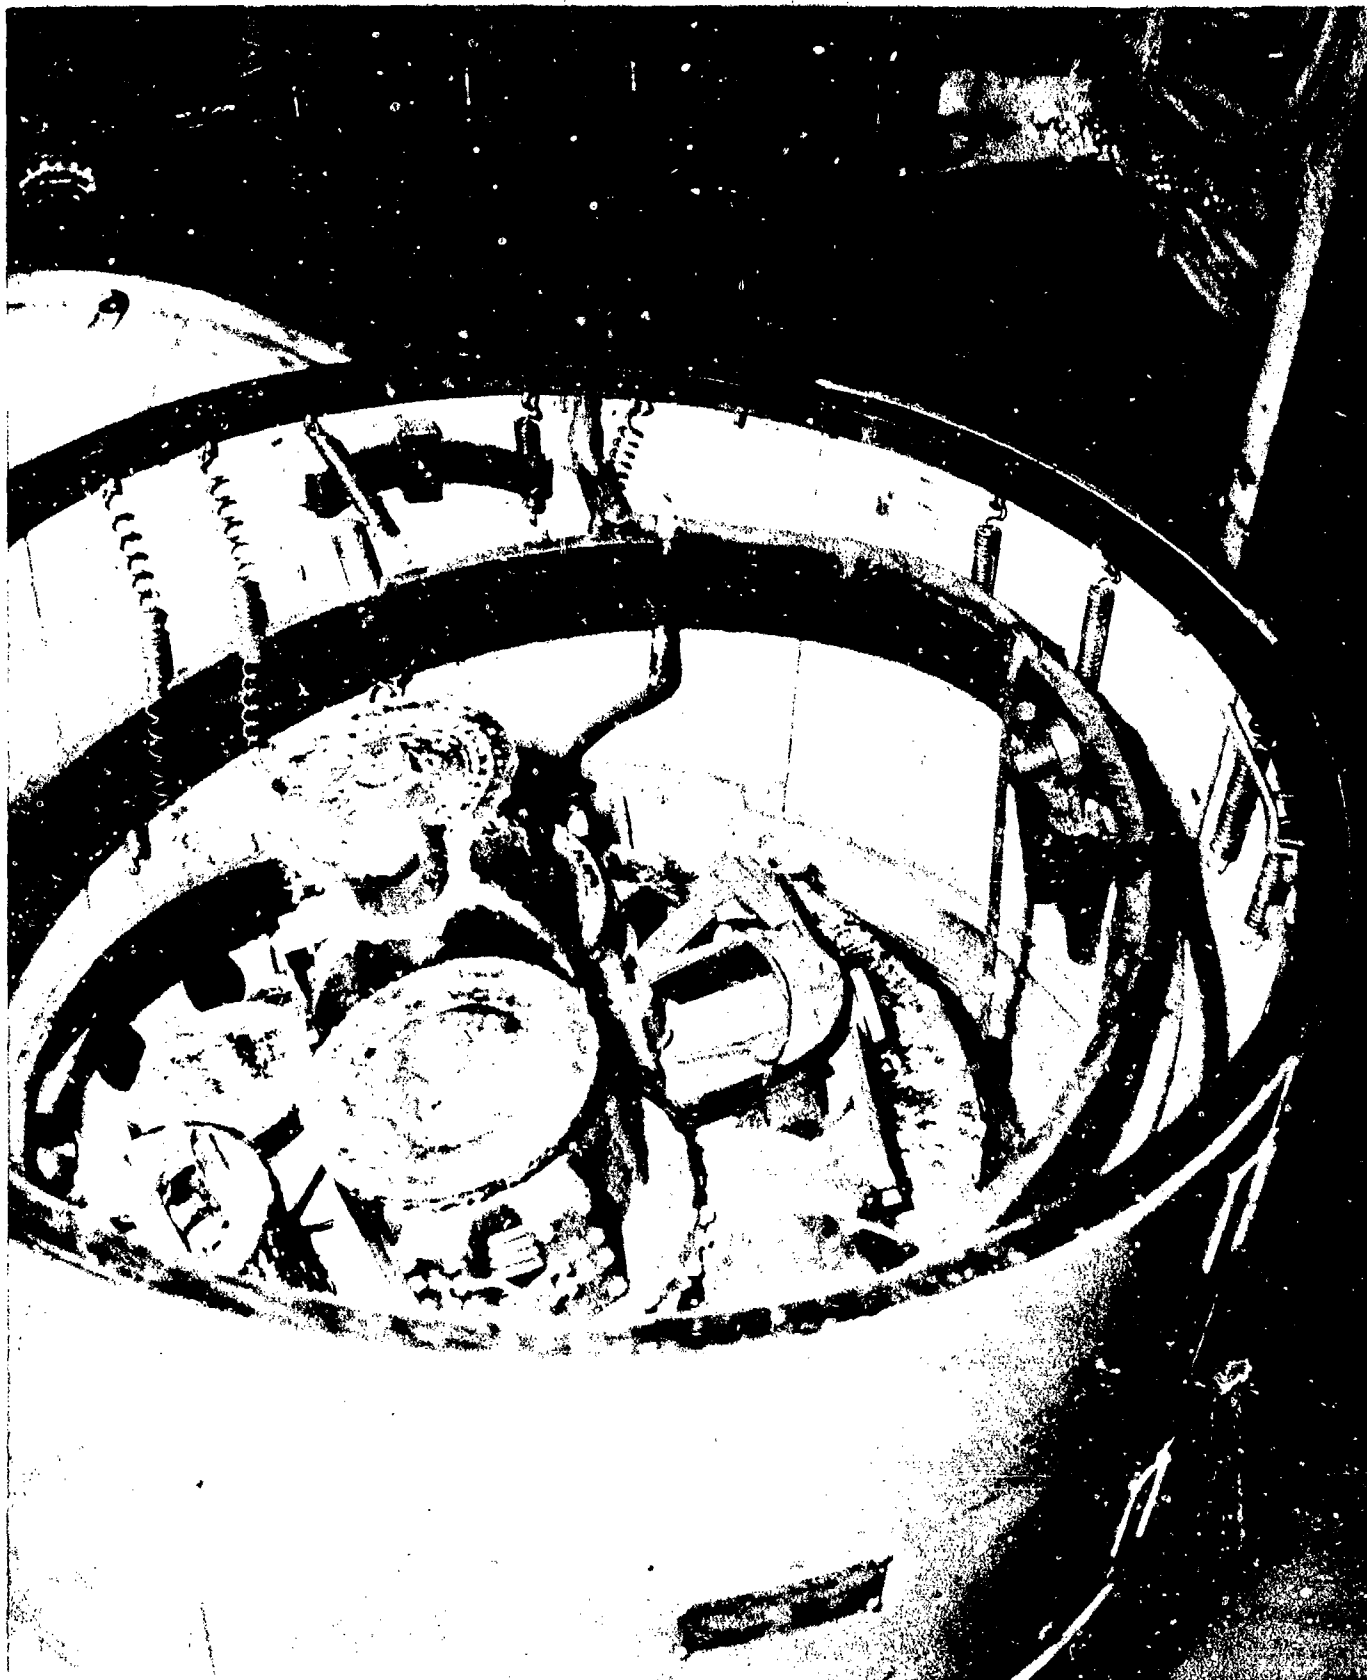
AB-CR-76-1934-1. Gyro compass mounted in the I.C. room. Shows damage to the gimbal mount, and gyro element dropped to the bottom of the binnacle. Dirt and silt were caused by flooding of the space.
